LUMINARY Memo #236

To: Distribution
From: L. Berman
Date: 23 December 1971
Subject: Crew Corrections for Cross Range Error due to Uncompensated Orbit Precession

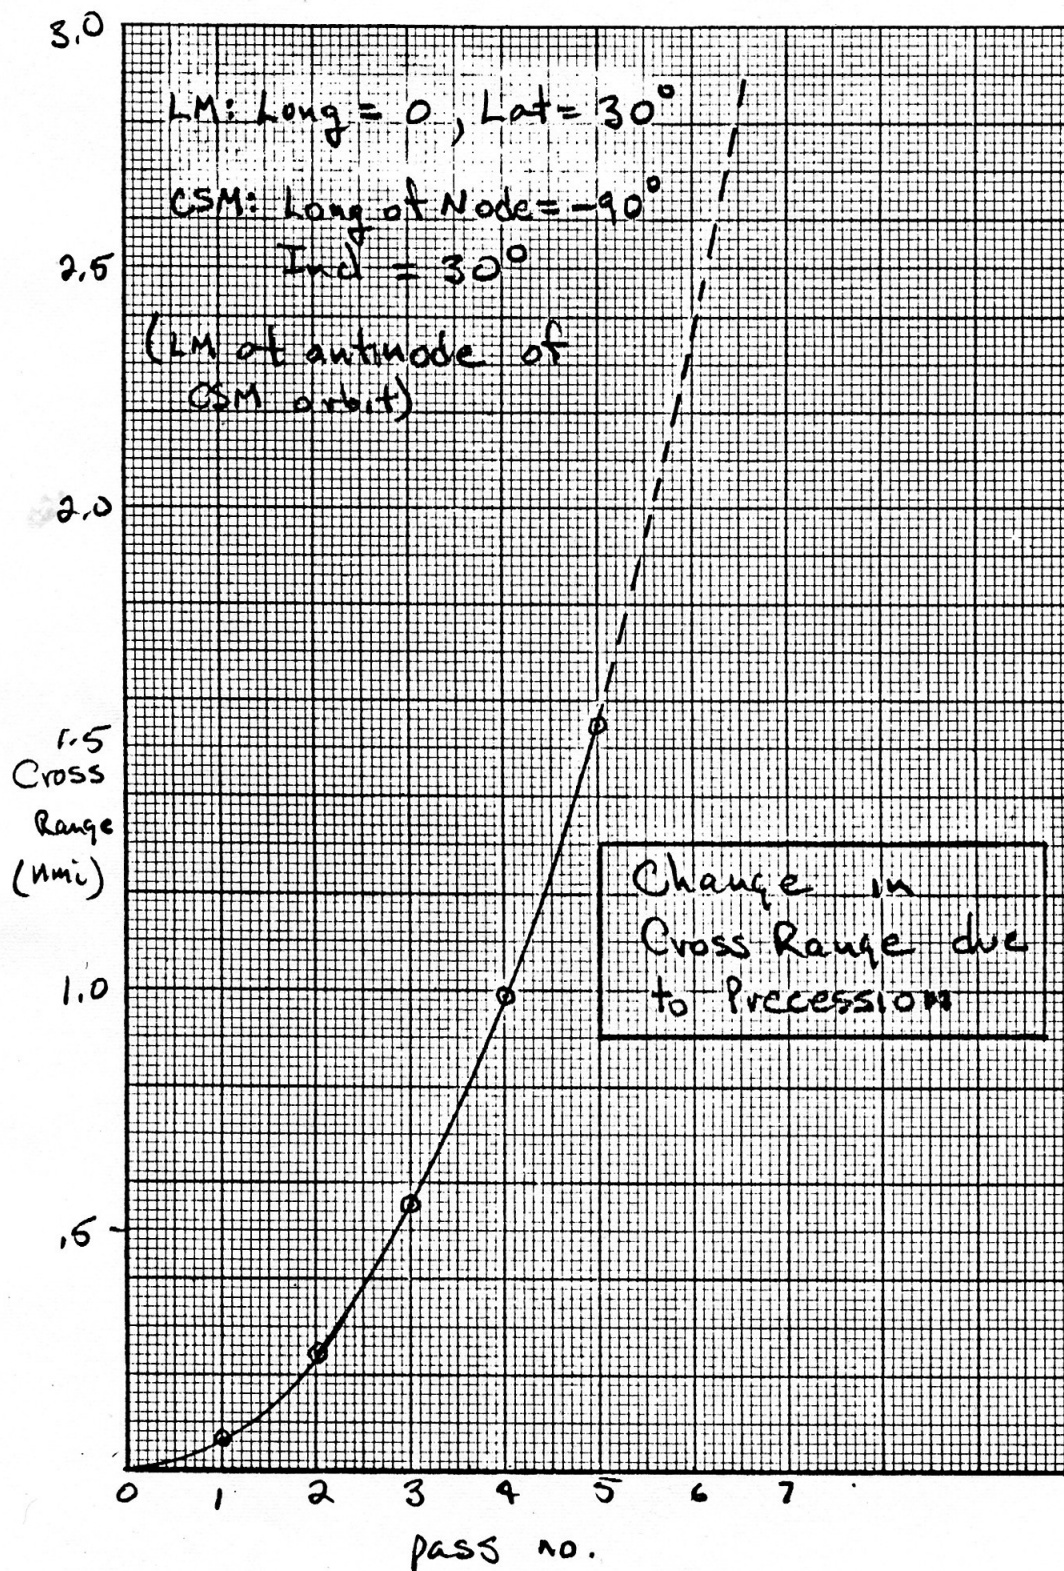
The attached figure shows the cross range for a 30° CSM orbit inclination, with the LM site at the anti-node at $t = 0$. This type of plot could be provided for actual RLS and CSM orbit, and the crew can then modify their response to Noun 76 to include this correction.

This correction can result in the insertion point being in the CSM orbit. It does not, however, account for the changed orientation of the CSM plane, and the LM may still have an incorrect heading at insertion.
